ANDREW FIREBRACE PARTNERSHIP

6 December 2018

Boundary Wall – St Mary the Virgin Church, Church Street, Fen Ditton

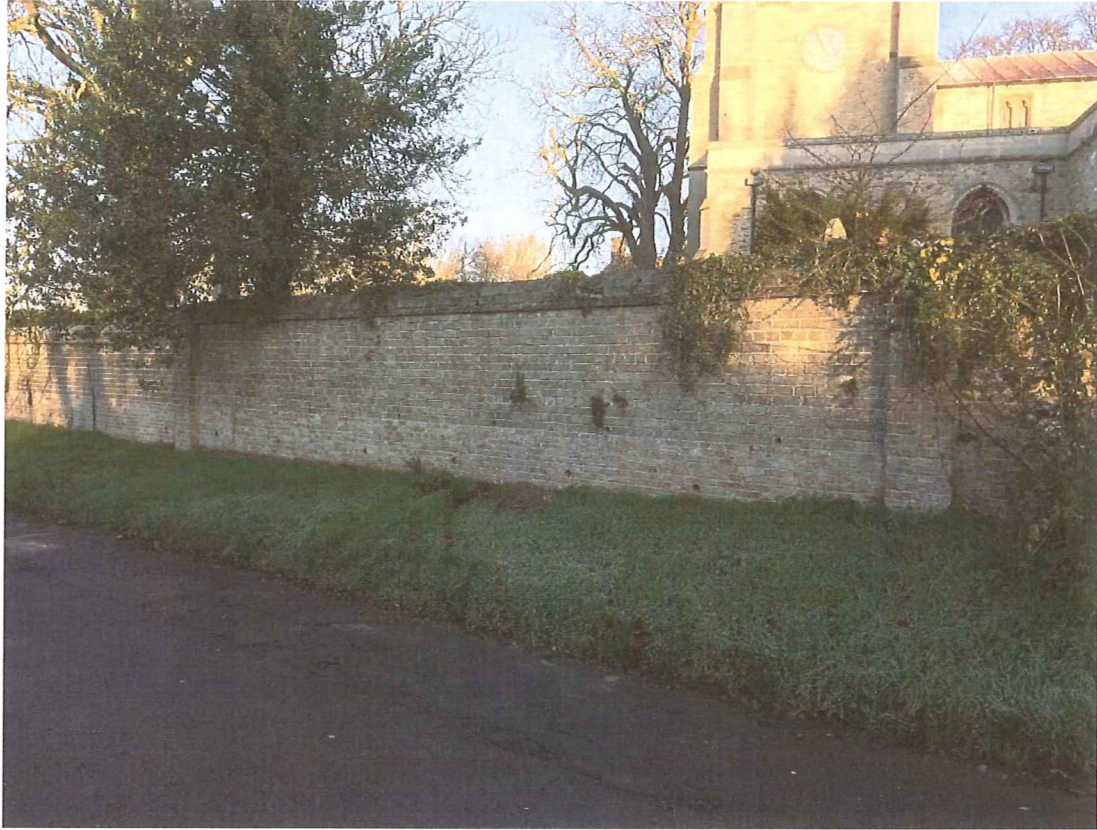
Photograph 1

Trial hole 1 was excavated to expose the foundations to what we believe to be a rebuilt brick section of the wall. This showed the foundation to be a shallow rubble concrete footing supporting corbelled brickwork. The foundation was bearing onto a firm chalk 400mm below ground level (refer to photos 1 and 2).

Trial hole 1 location.

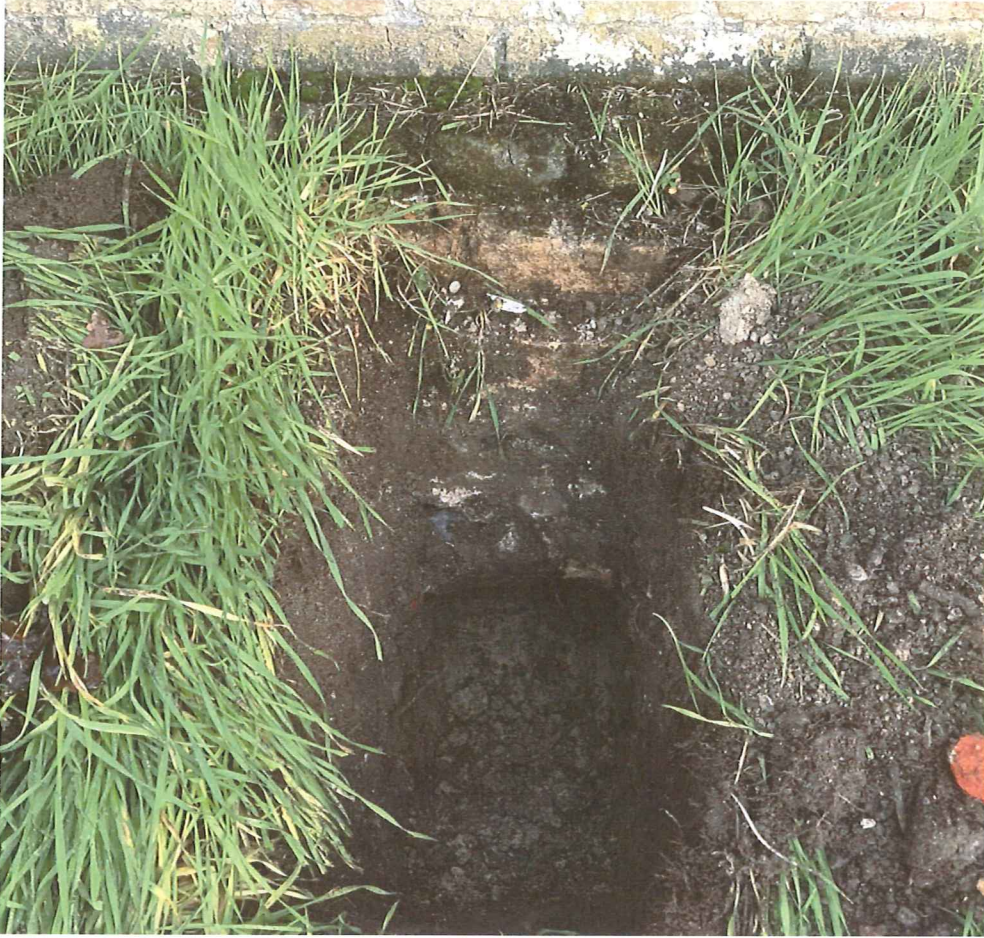
Photograph 2

Trial hole 1.

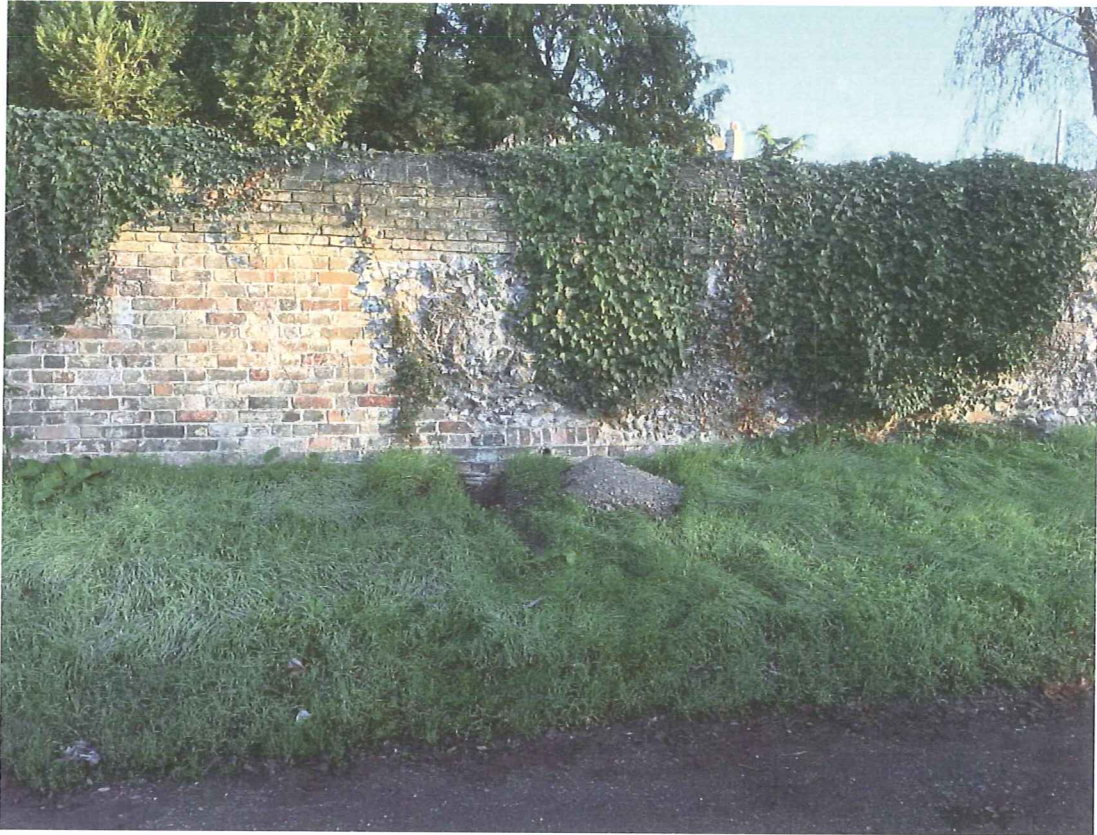
Photograph 3

Trial hole 2 was excavated on a section of wall which had a low section of brickwork then flintwork topped with a brick capping. The trial hole showed the foundation to be 330mm deep bearing onto the chalk (refer to photos 3 and 4).

Trial hole 2 location.

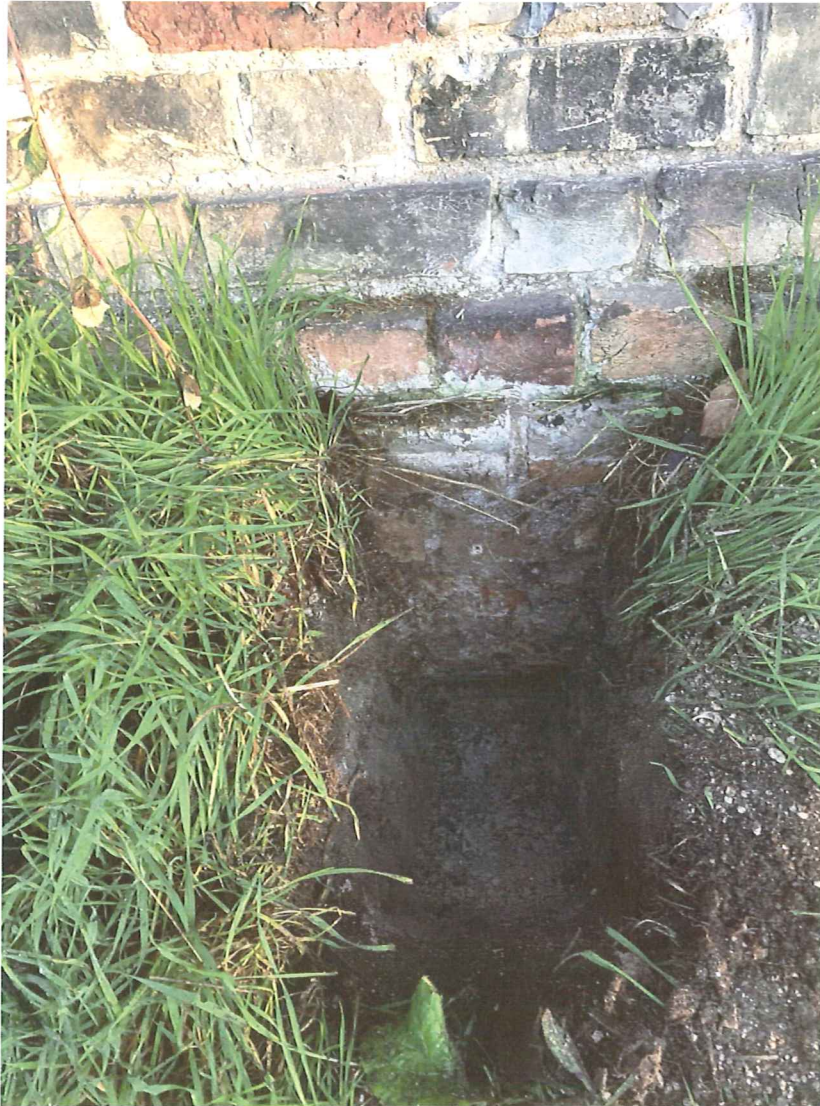
Photograph 4

Trial hole 2.

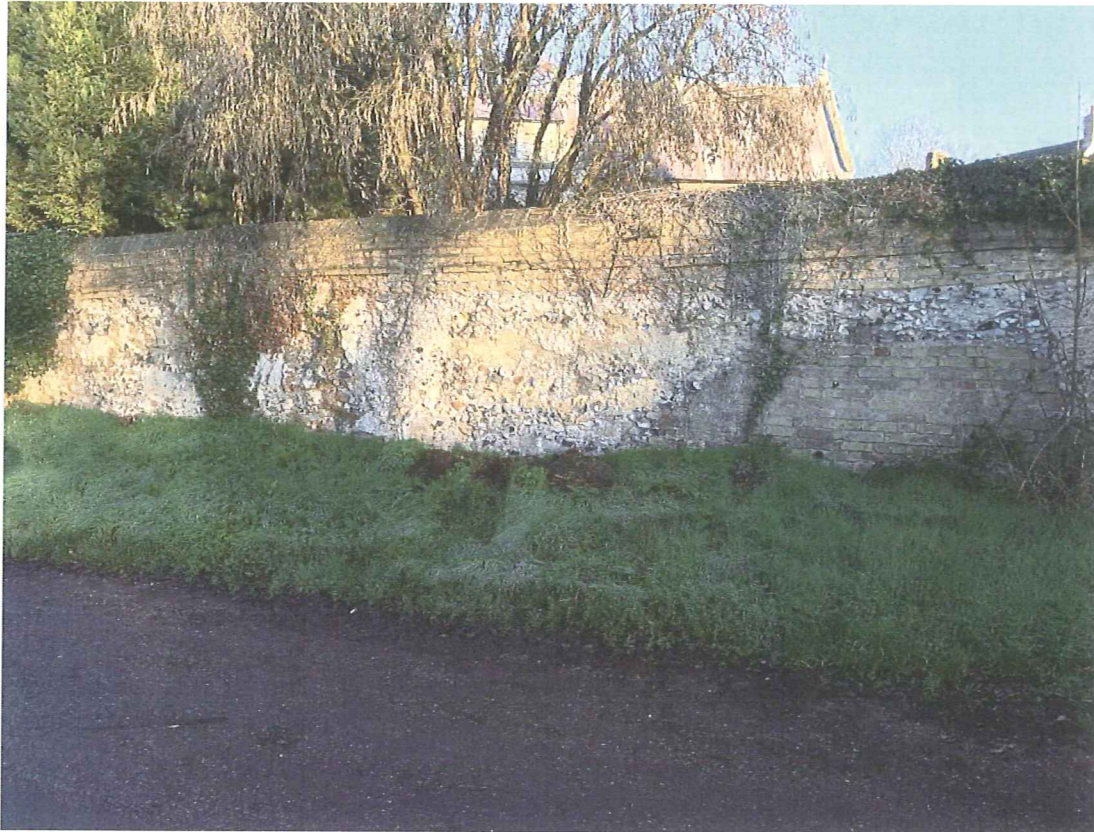
Photograph 5

Trial hole 3 was against a section of wall where the flintwork extends down to ground level. This section had almost no foundation. The flints extended down 100mm below ground level. They did though bear onto the chalk (refer to photos 5 and 6).

Trial hole 3 location.

From our inspection it is evident that significant sections of the wall are in poor condition and have very shallow foundations. It is recommended that these sections of the wall are rebuilt in brickwork with a reclaimed flint outer face and reclaimed brick capping, all atop a new concrete foundation. It will be necessary to have a free drainage gravel material placed behind the wall with weep holes through the wall to ensure that the water from the soakaway does not build up behind the wall causing additional lateral force.

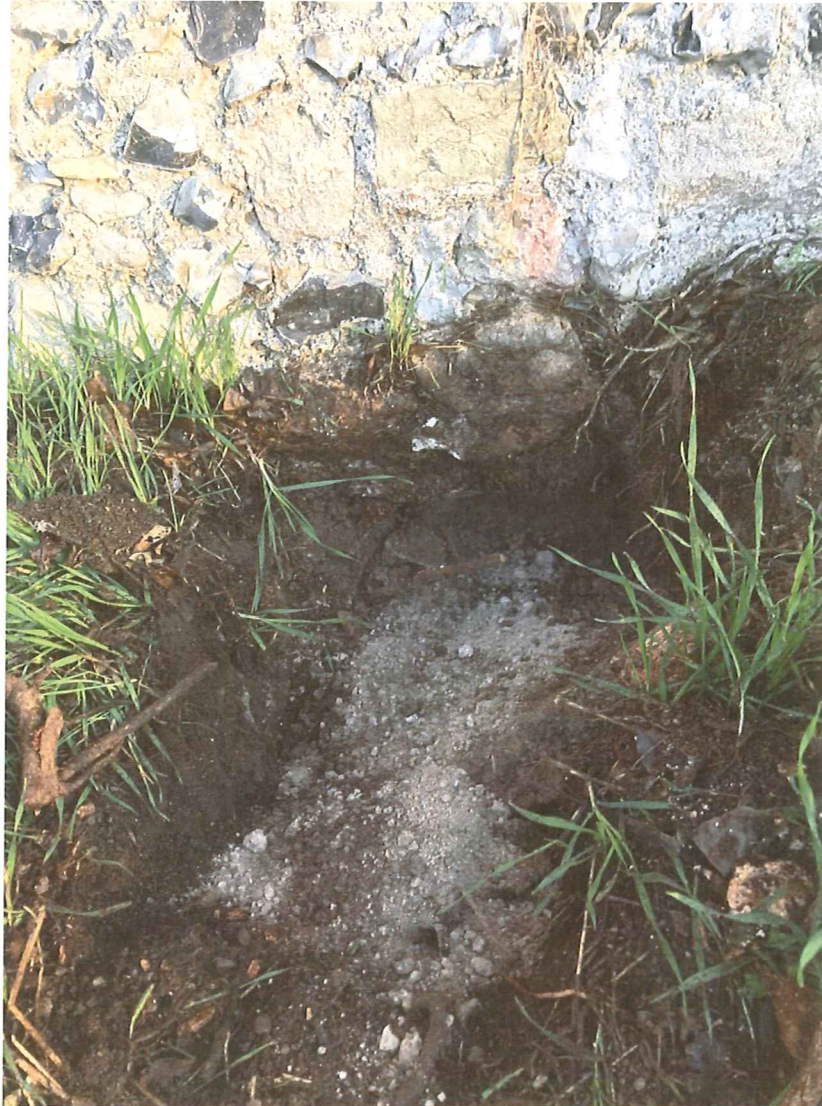
Photograph 6

Trial hole 3.

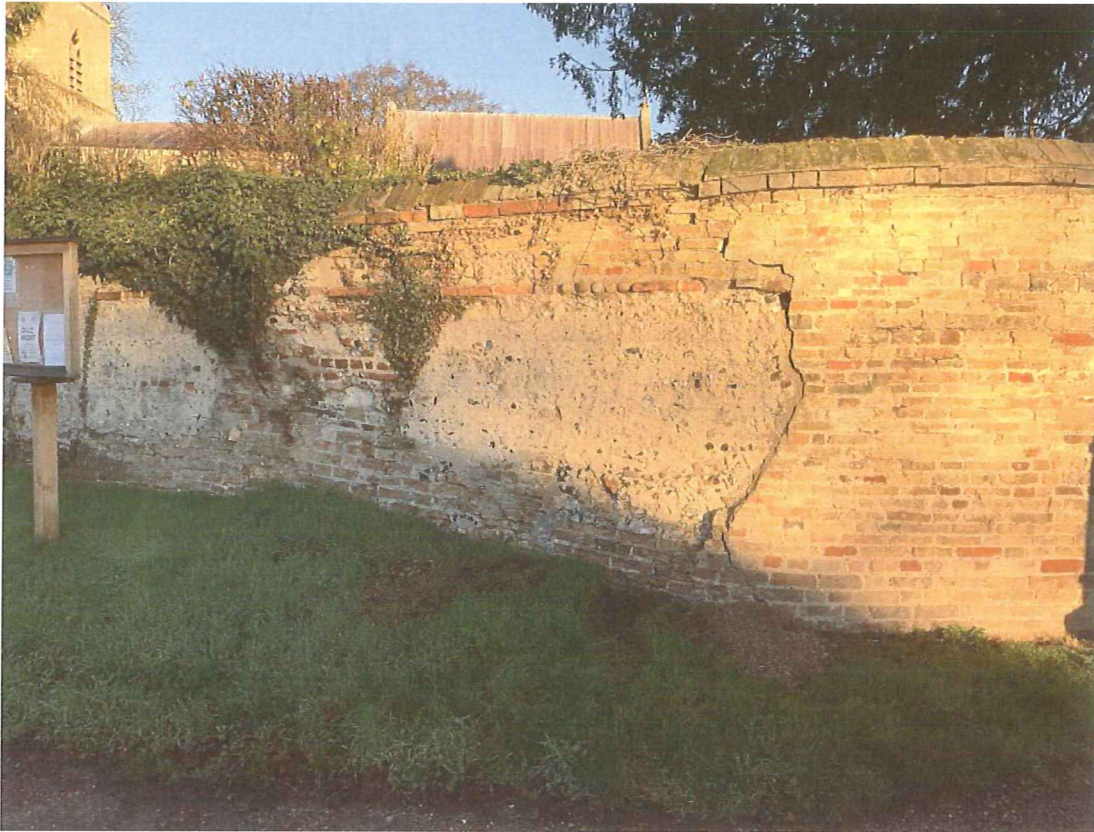
Photograph 7

Trial hole 4 was up against the wall near the curved section of wall adjacent to the entrance gate to the church. This showed there to be a rubble concrete footing bearing onto the chalk 300mm below ground level.

Trial hole 4 location.

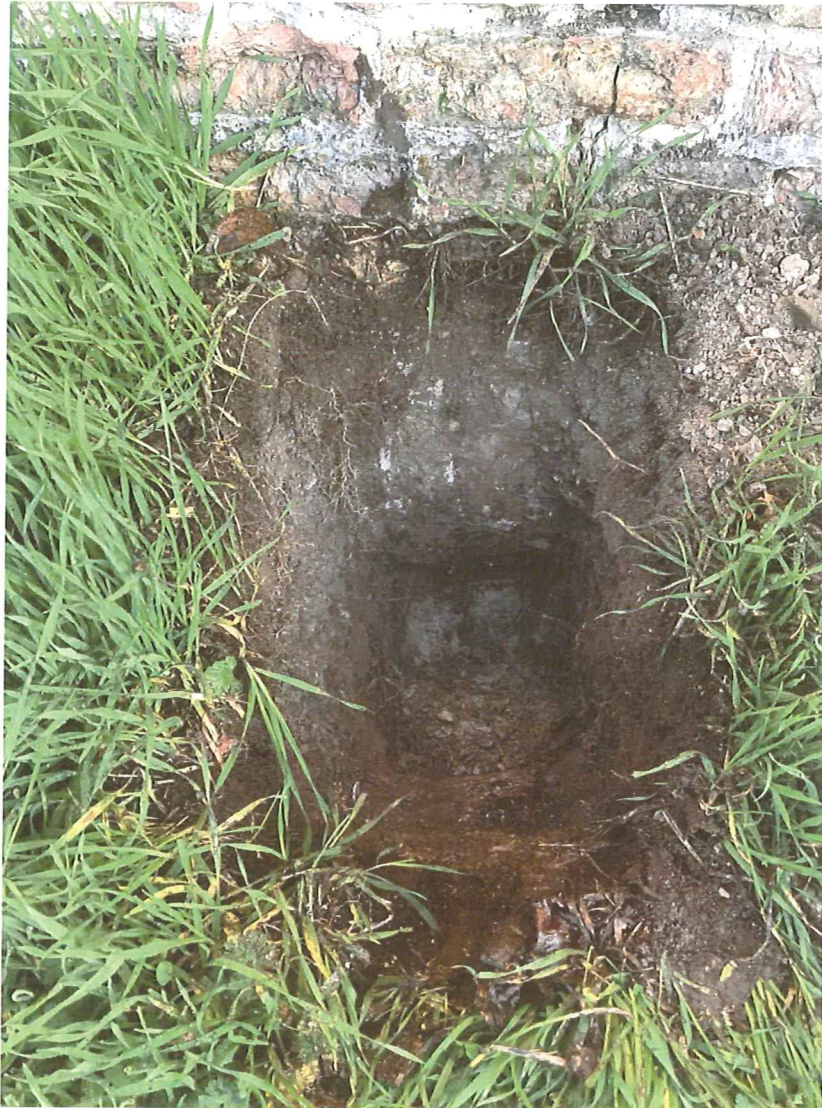
Photograph 8

Trial hole 4.

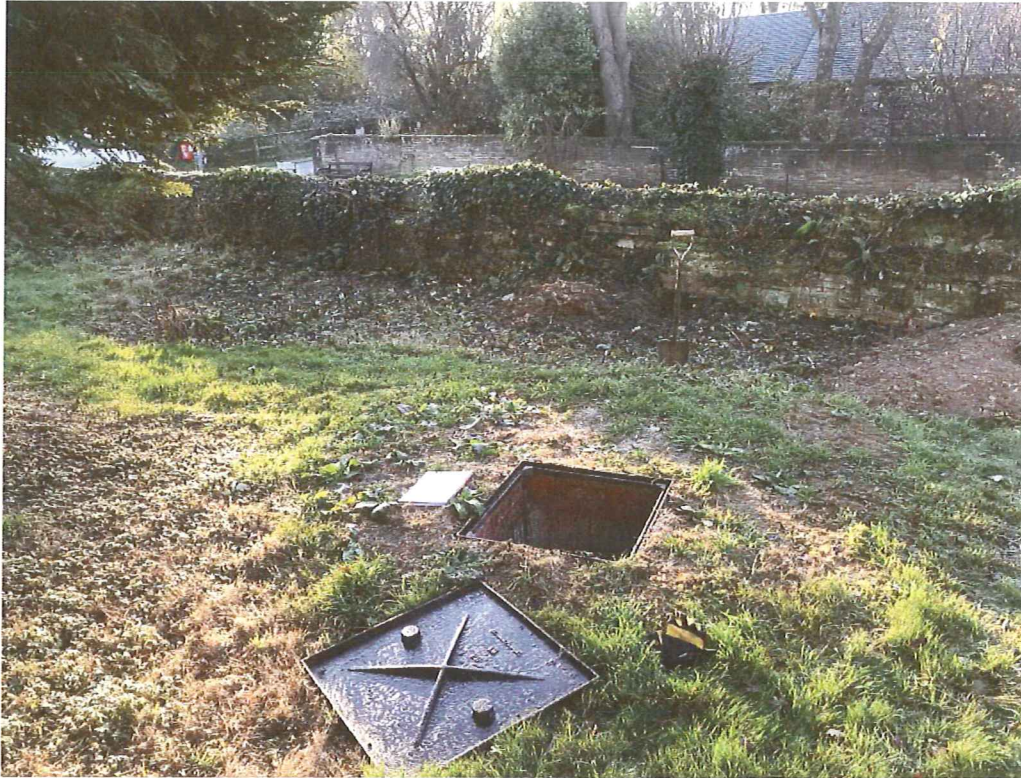
Within the church yard there was a manhole cover. Lifting this revealed a large modern soakaway. The soakaway was constructed of 1.8m diameter precast concrete rings. The edge of the soakaway was only 1.5m from the back of the boundary wall. The bottom of the soakaway appeared to be at or near the same level as the roadway on the other side of the boundary wall.

Location of soakaway within church yard.

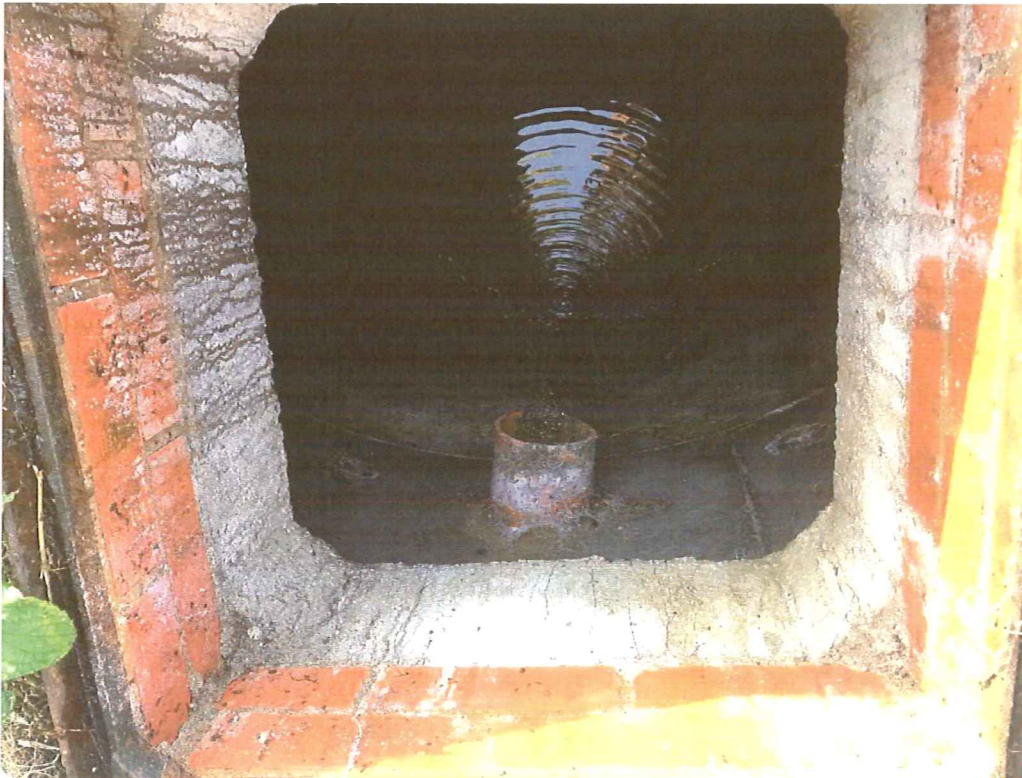
View inside soakaway. Approximately 1800mm diameter concrete rings approximately 1.5m from back of wall. Depth approximately 1.8m

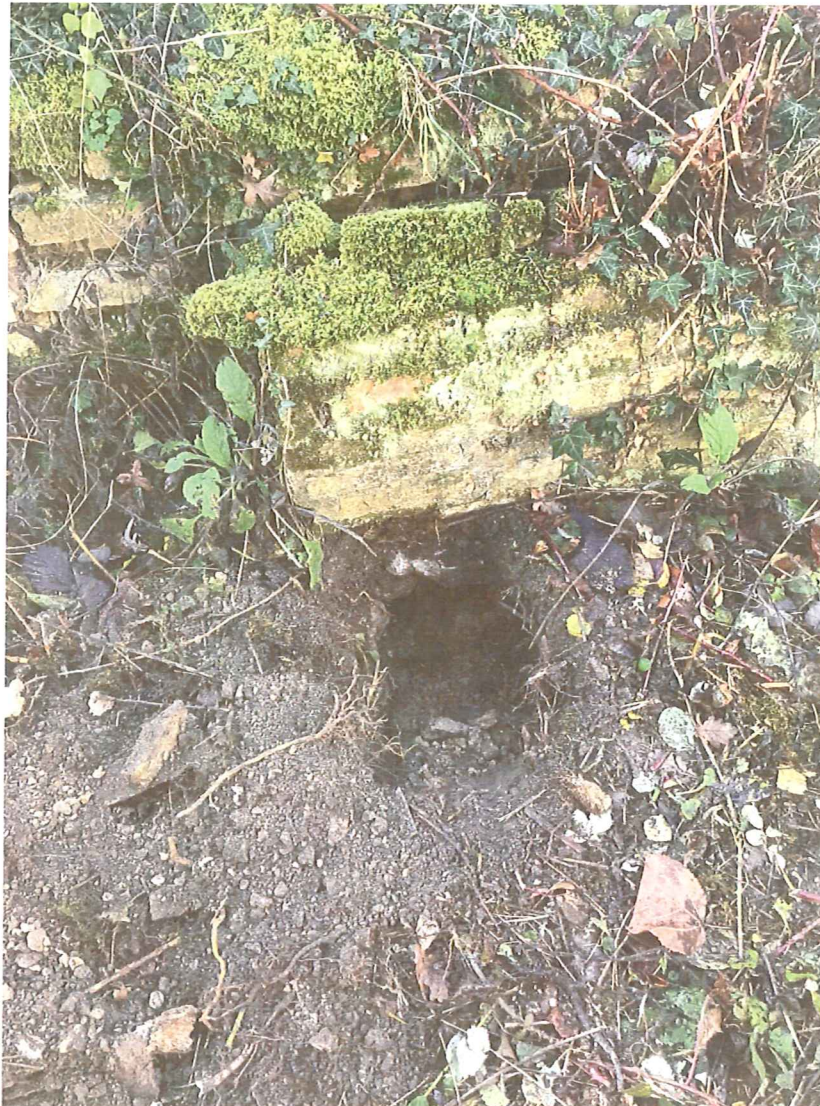
Internal trial holes showed the upper brick capping to the wall to be wider than the original flint wall and to be founded at a very shallow depth and bearing onto the fill behind the main retaining wall. The back of the main retaining wall appeared to be flintwork.

Trial hole within church yard showing upper brickwork capping having shallow foundation with flintwork to main wall set back and extending downwards.

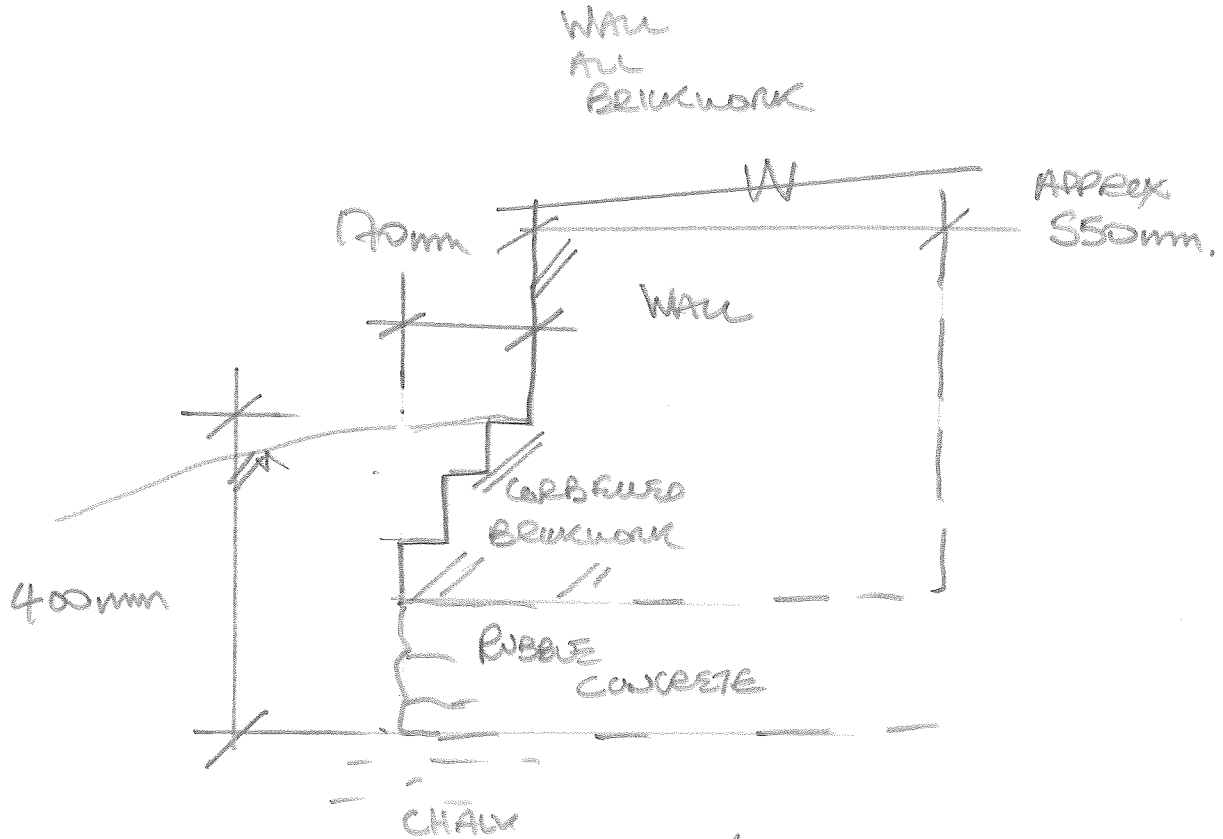
TRIA HOLE ① (REBUILT SECTION OF WALL?)
REFER TO PHOTO 1+2

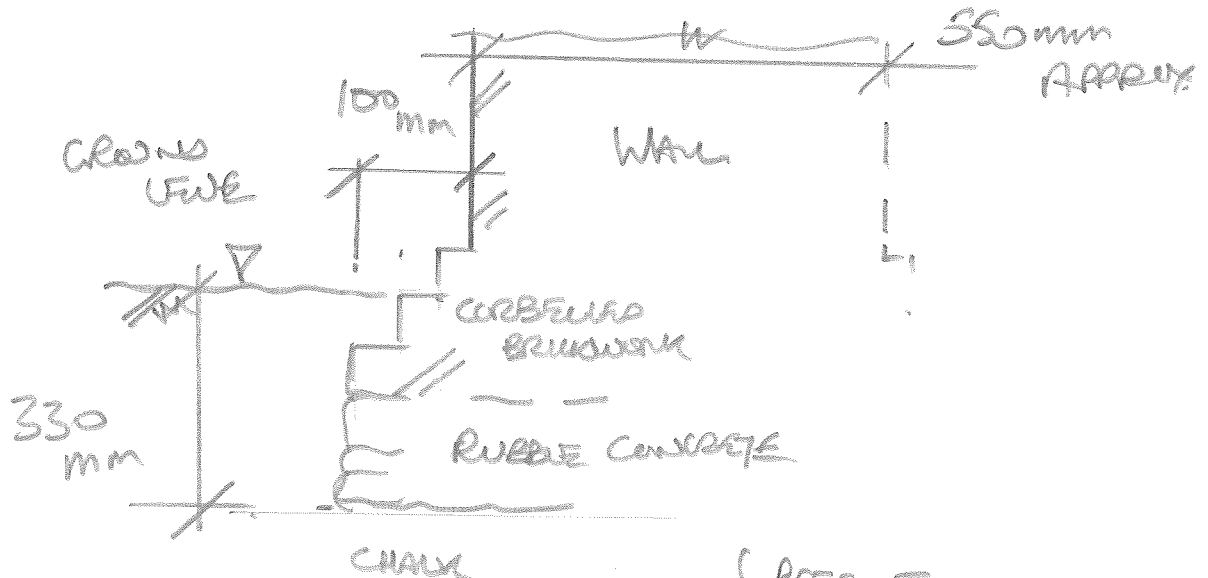
TRIA HOLE ② (REFER TO PHOTO 3+4)

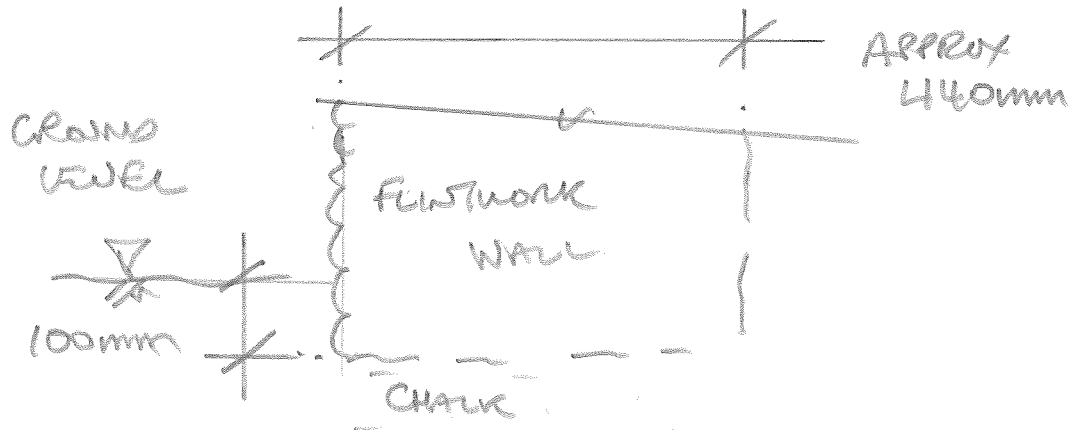
TRIAL HOLE (3)
(REFER TO PHOTOS 5+6)
